Manhole Inspection Summary

Manhole # S27Q1_009MH

Inspection ☐ Is Incomplete Rating: **4) Poor**

Insp Date: **3/10/08 10:31 AM**

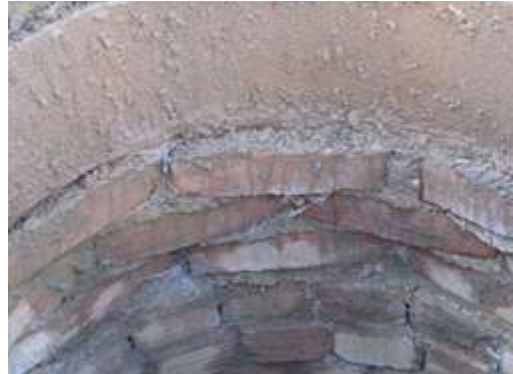
Defect 1

Chimney / Frame Adjustment ☒ Exists Material: **Brick** ☐ Parged Height: **6** (in.)
Condition: ☒ Sound ☐ Cracked ☐ Root Intrusion ☐ Loose Brick ☐ Deteriorated
Infiltration: ☐ None ☐ Joint ☐ Cracks ☒ Mortar ☐ Roots ☐ Wall

Chimney

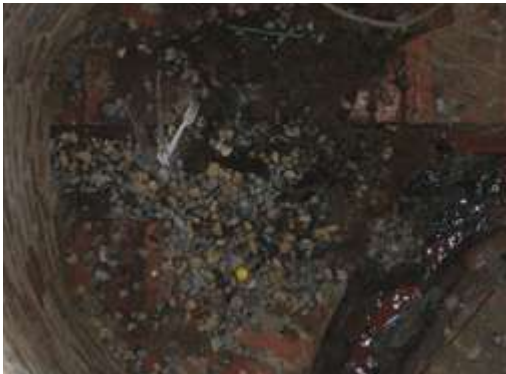
Defect 2

Channel Material: **Brick** ☐ Parged
Channel Exposure: **Partially Open** Junc Dist: **0** nearest .5 ft. Azimuth:
Condition: ☐ Sound ☐ Cracked ☐ Root Intrusion ☐ Deteriorated ☐ Leaks ☒ Debris

Channel filled with debris

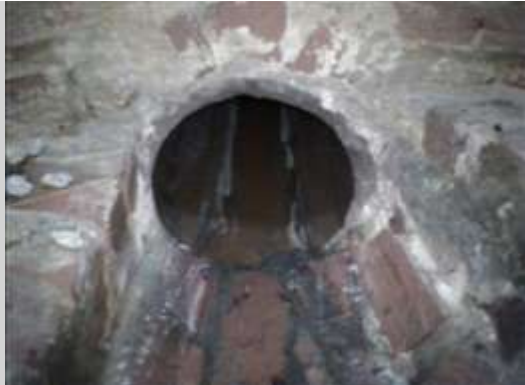
12 O'Clock Outflow

8 in. Circular Gravity Sewer
Pipe Out @ 12 O'Clock

Pipe Height: **9.6** (in.) Rod and Bar (Angled)
Pipe Material: **Clay** ☐ Pipe Lined
Invert Depth: **10.22** (ft.) Flow Characteristics: **Fast**
Deposits: ☒ None ☐ Mud ☐ Sludge ☐ **Debris** ☐ Grease
Silt Depth: (in.) Deposits Extent:
Infiltration: **None** Pipe Seal Cond: **Sound**

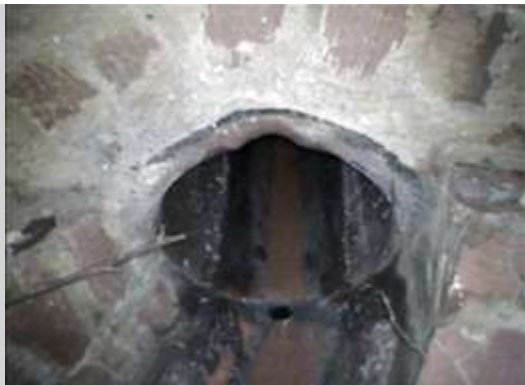
3 O'Clock Inflow

8 in. Circular Gravity Sewer
Pipe In @ 3 O'Clock

Pipe Height: **9.6** (in.) Rod and Bar (Angled)
Pipe Material: **Clay** ☐ Pipe Lined
Invert Depth: **9.95** (ft.) Flow Characteristics: **Fast**
Deposits: ☒ None ☐ Mud ☐ Sludge ☐ **Debris** ☐ Grease
Silt Depth: (in.) Deposits Extent:
Infiltration: **None** Pipe Seal Cond: **Sound**

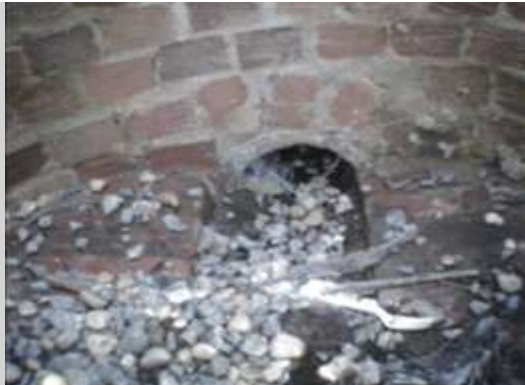
6 O'Clock Inflow

8 in. Circular Gravity Sewer
Pipe In @ 6 O'Clock

Deposits: ☐ None ☐ Mud ☐ Sludge ☒ **Debris** ☐ Grease

Silt Depth: **3** (in.) Deposits Extent: **Heavy**
